Compressor Train Retrofit Improves System Reliability and Output

GASPAC Dry-Running Gas Seals Key to Successful Solution

Bulletin FSG-SS-015 (E/A4) Printed in USA. December 2010.
© Flowserve Corporation

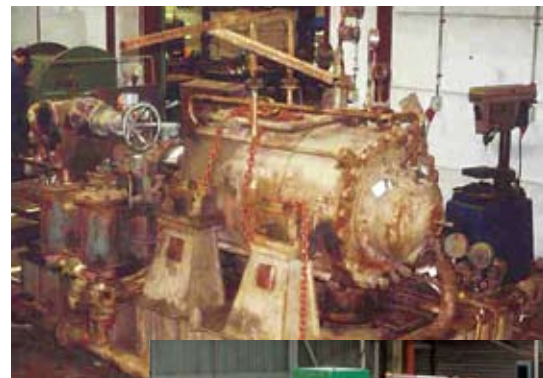
In 1997, the Nerefco Rotterdam Refinery was experiencing severe reliability issues with the steam-driven, sevenstage BCL Nuovo Pignone compressor providing recycle gas service in its CDU. Bad rotor-dynamic behavior, including oil whip and excessive vibration due to seal-oil build-up on the impellers, had resulted in several failures. Furthermore, inadequate steam supply and poor steam quality were limiting the output of the compressor.

Before

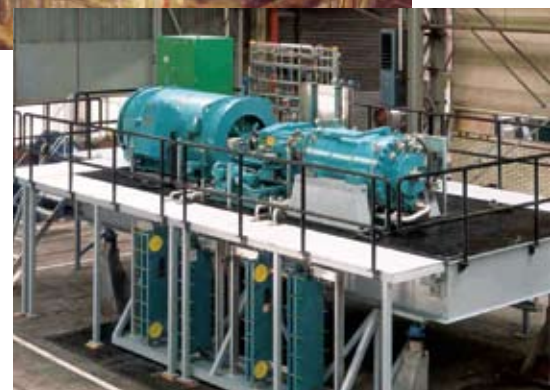
After (Packaging at Flowserve facility)

Compressor capacity issues were addressed by replacing the steam turbine with a 1400 kW (1877 hp) electric motor and a fluid coupling/step-up gear. This enhancement allowed a stepless speed regulation from 4000 rpm to 12 970 rpm. The new drive configuration, however, resulted in a footprint too large for the existing concrete foundation table. Compounding the problem, the project timetable precluded extensive new civil construction.

Flowserve introduced a new foundation concept for refineries, a "low-tuned" honeycomb steel skid with spring supports that virtually eliminated sensitivity to operating excitation forces. (Sensitivity to nozzle load forces and foundation resonance were also minimized.) The entire compressor train, with all instrumentation, control and auxiliary systems, was constructed and tested in a Flowserve Service Center and then transported to the refinery CDU. With the new non-grouted foundation/baseplate, installation and commissioning was accomplished in just 2.5 weeks.
